Hotspot Seal Pot Detection of PLTU Teluk Sirih

Benny Dwika Leonanda¹, Dendi Patrio Putra², *

¹ Graduate School Engineer Professional Program Study Program and Mechanical Engineering Department, Andalas University
² PLTU Teluk Sirih, Padang, Sumatera Barat

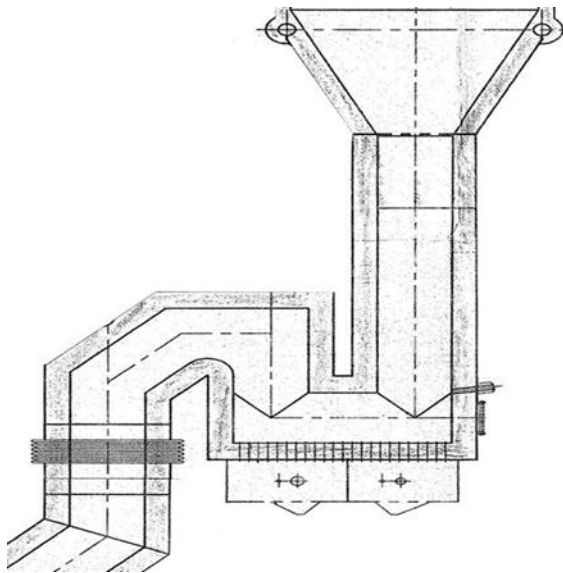
Figure 1 Seal spot for Unit 1 PLTU Teluk Sirih

combustion chamber. There are two seal pots, namely seal pot A and seal pot B. Currently, the seal pots are experiencing issues with the formation of hotspots (areas with excessively high temperatures) at certain locations. To prepare the procurement documents for the seal pot repair project, surface temperature measurements of the outer casing of the seal pots are being conducted to detect hotspots and undesirable temperature increases.

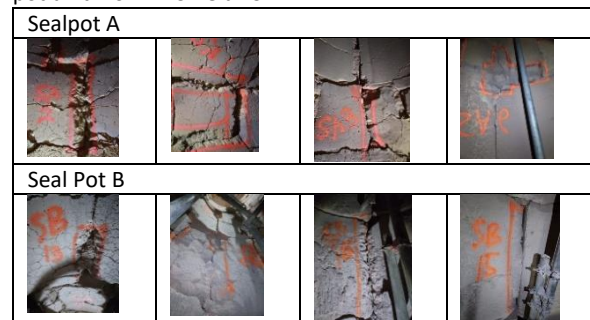
Table 2 Documentation of failure of the refractory seal pot unit 1 of PLTU Teluk Sirih

Based on the images in Table 2, it is evident that the surface of the seal pot has experienced damage. Certain areas of the surface have undergone degradation and cracking. The thinning and cracking of the surface will result in hotspots on the seal pot's shell..

- Hotspots occur as a result of previous refractory damage, which may have occurred due to either reaching the end of its service life or premature damage caused by operational errors in the power plant.
- The temperature measurements conducted on the surface of the seal pot revealed that only 13% (6 measurement points) were operating normally below 110°C, while the remaining points were in a hazardous

3. It is imperative to promptly repair the refractory of the seal pot as the presence of hotspots alone can potentially lead to fires.
4. With the completion of the seal pot temperature measurements, the resulting data can be utilized as technical information to prepare procurement documents. This includes technical specifications, project timelines, contract requirements, and supplier/contractor evaluation criteria.
