# Special Performance Evaluation of Photo Voltaic Power Plant in Gili Trawangan Solar Power Plant to Achieve Photovoltaic Reliability Excellence

The PV power plant at Gili Trawangan is designed as a microgrid system. This paper also is intended to assess an early fault and perform special maintenance procedures on the Gili Trawangan PV Power Plant.

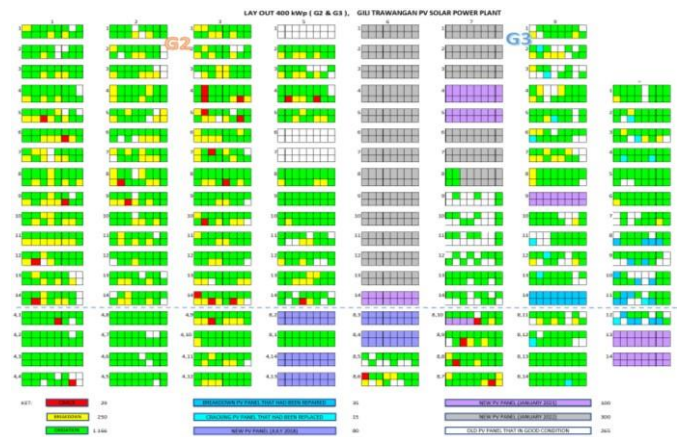
Fig. 2. PV Array and Module Failure Mapping of Gili Trawangan PV Power Plant

PV modules assess one by one to ensure that there are no broken solar modules, damaged lamination (air bubbles), discolored cells, snail tracks, short circuits. The result of PV Solar Module Failure Mapping especially for G2 and G3 Inverter of Gili Trawangan Solar PV can be shown in Fig. 2.

Almost 50% out of 3,160 PV Modules, are experienced problems such as Oxidation (37%), Cracking (1%) & Breakdown (8%). Based on data, the 3 inverters that experienced the most problems (damaged) were inverter G2 followed by inverter G3. The large number of damaged PV modules is taken into consideration for taking proper maintenance actions and even planning to replace PV Modules accordingly to increase the penetration of solar energy.

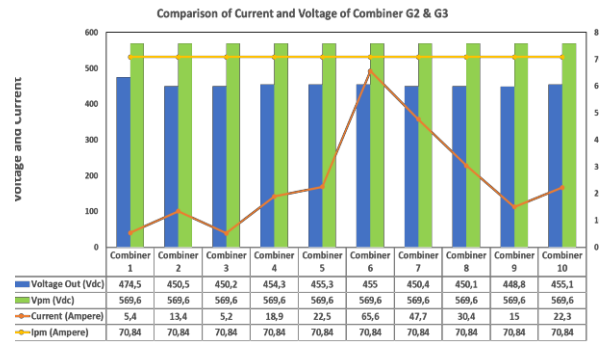
Fig. 5. Comparison of current and voltage of Combiner G2 and G3

The comparison value of the current and voltage of the Combiner G2 and G3 with the standard name plate is illustrated as shown in the Fig. 5 below.

If each data on the name plate is assumed to be the maximum value that can be taken as a comparison, then for each string with a current ( $I_{pm}$ ) of 5.4A connected in parallel, the maximum output current ( $I_{pm}$ ) on the combiner is 70.84A. From the graph above, the actual voltage and current values are still far below the standard maximum current values according to the nameplate, especially the current values that are achieved very low with an average value of 13.08 amperes or 18.46% (inverter G2) and 36.20 amperes or 51.10% (inverter G3). This achievement is very low compared to the maximum current condition ( $I_{mp}$ ) that should be obtained.

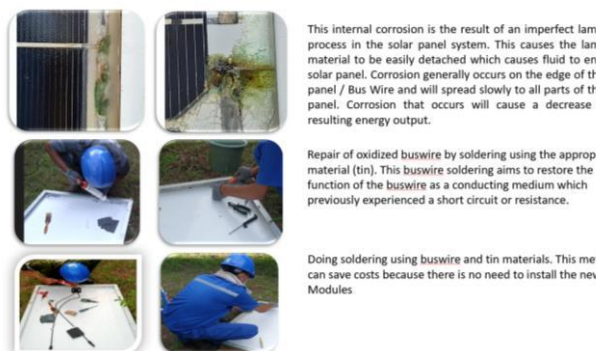
Fig. 7. Special Maintenance by repairing buswire of PV Module

The illustration of special maintenance by repairing the oxidized buswire is shown in the Fig. 7 below.

- Repairing oxidized buswire soldering by using the appropriate material (tin) to restore the function of the buswire as a conducting medium which previously experienced a short circuit or resistance.
- Periodic replacement of diode blocking based on current and voltage monitoring on the combiner.
- Monitoring all the installations from PV Modules to Inverters, both measuring voltage & current and inspecting the physical condition of Solar PV Power Plant components.

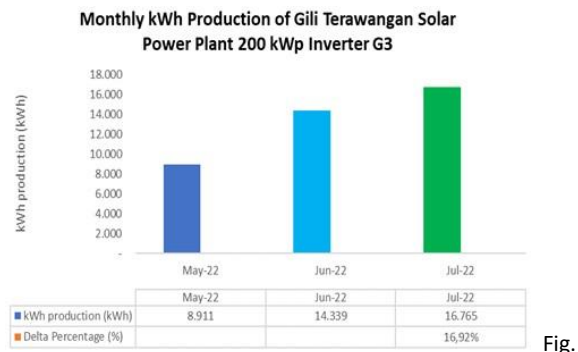
8. Comparison kWh Production of Gili Trawangan Solar Power Plant 400 kWp G3 from May 2022 to July 2022

The benefit and effect after repairing buswire PV module can be shown in the following graph. Regardless the changes in weather and ambient temperature, from the graph below, there has been an increase in production after buswire repairs were conducted during the period May 2022 – July 2022 with an average increase of 16% each month.
